## WEEKLY SUMMARY REPORT

| Client: | Needham DPW | Dates: | 11/11/2019 to 11/15/2019 |
| Contract: | Rosemary Lake Dredging | | |

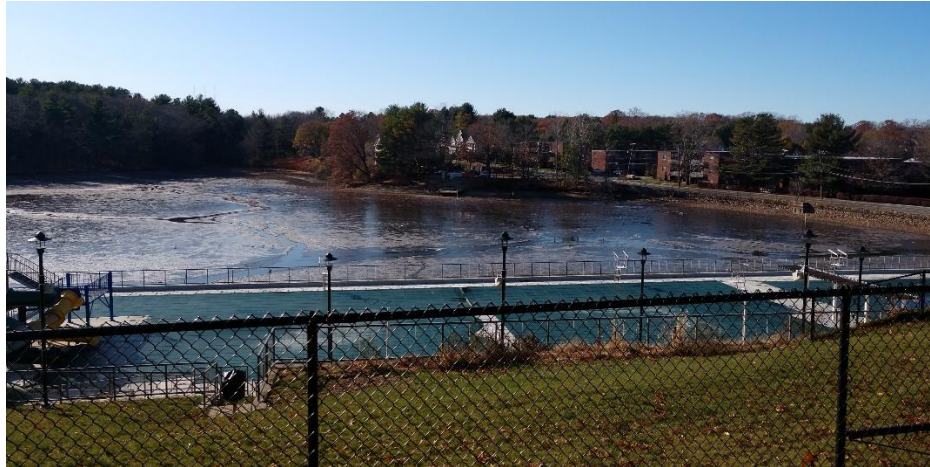
Wednesday (11/13/2019)

**View of Lake from Pool Yard - Drawdown progress**

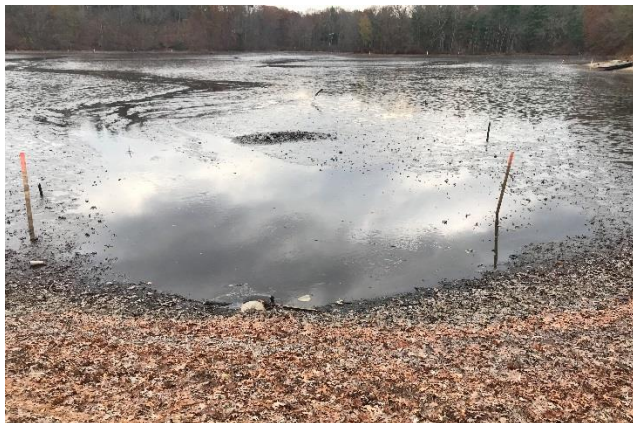
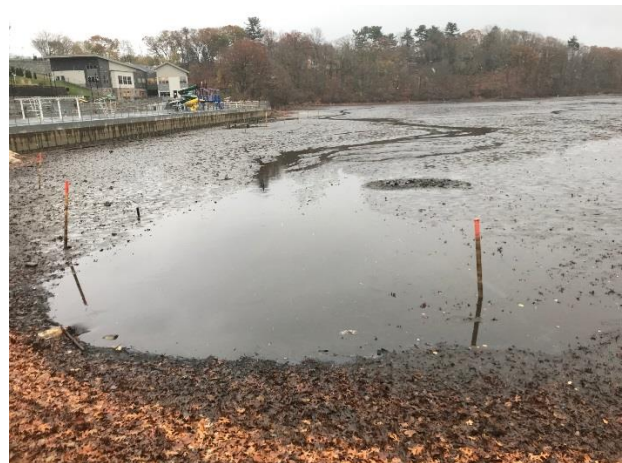
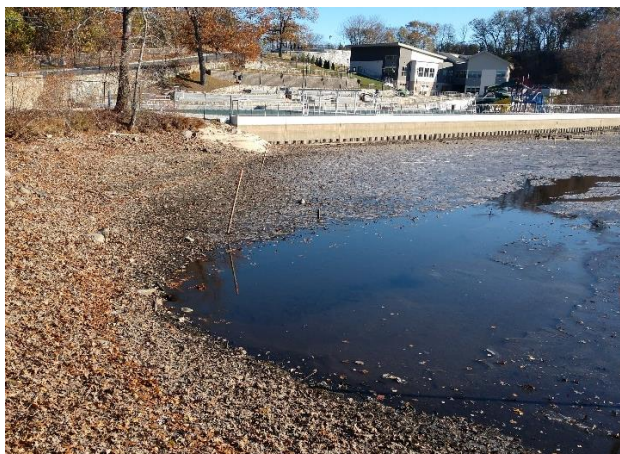
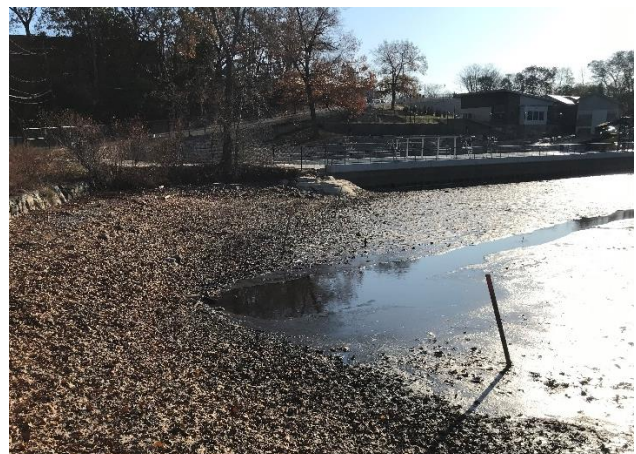
### Lake outlet - Drawdown progress

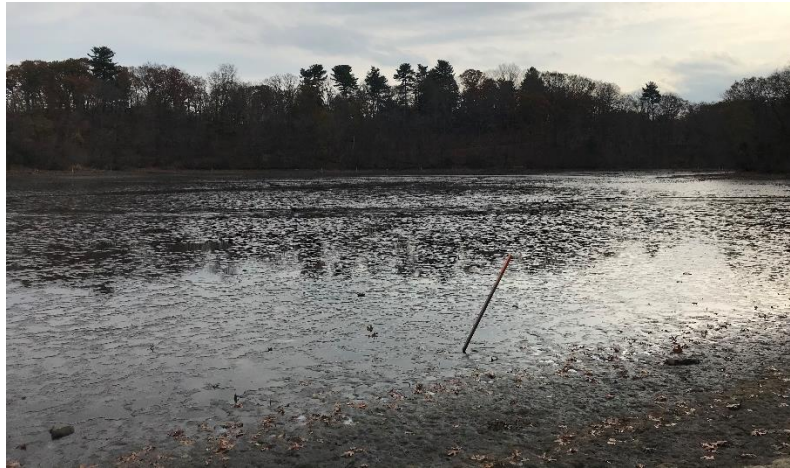
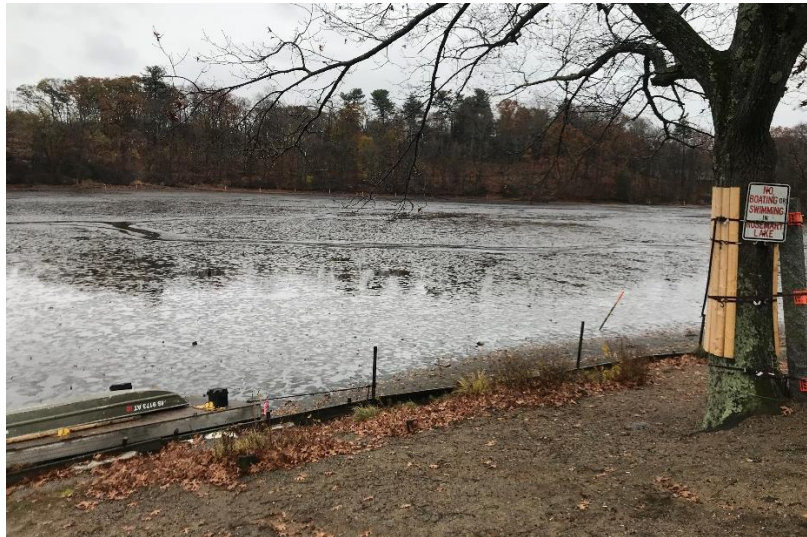
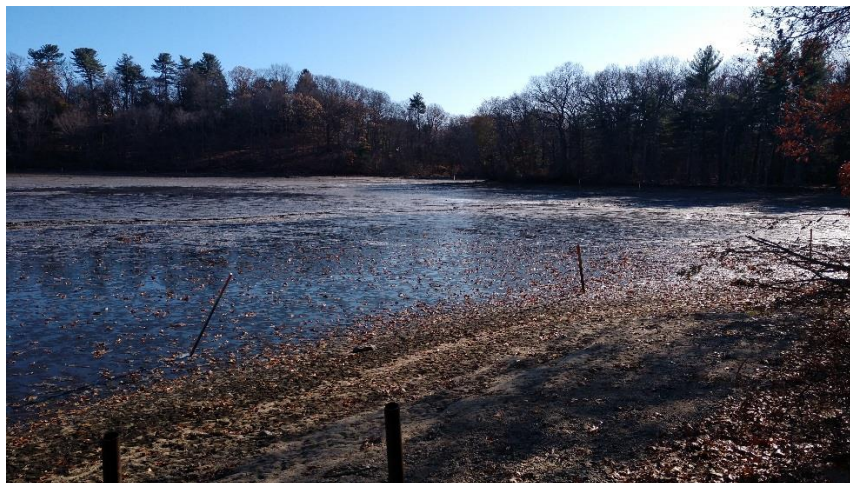
**View of Lake from Staging Area - Drawdown progress**

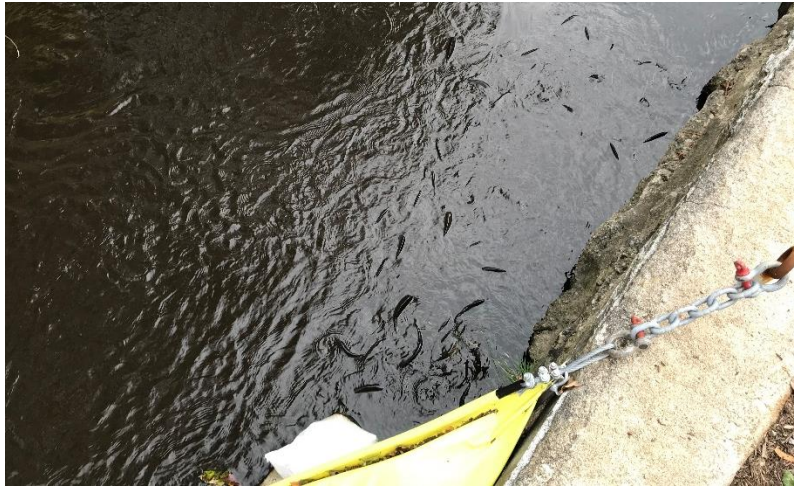
Monday (11/11/2019)

**Station 1 (Petrini Property) – Fish noted by turbidity curtain – many relocated past curtain.**

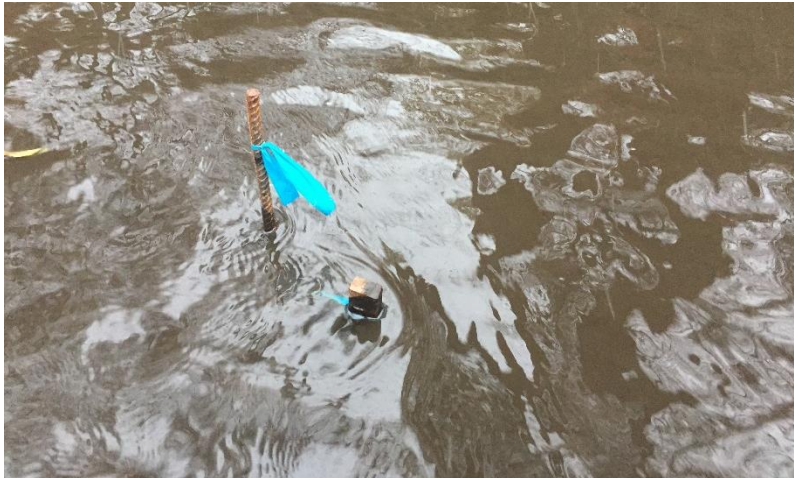
Tuesday (11/12/2019)

**Station 1 (Petrini Property) – Turbidity, velocity, and sediment depth readings taken on Monday, Tuesday, and Friday.**

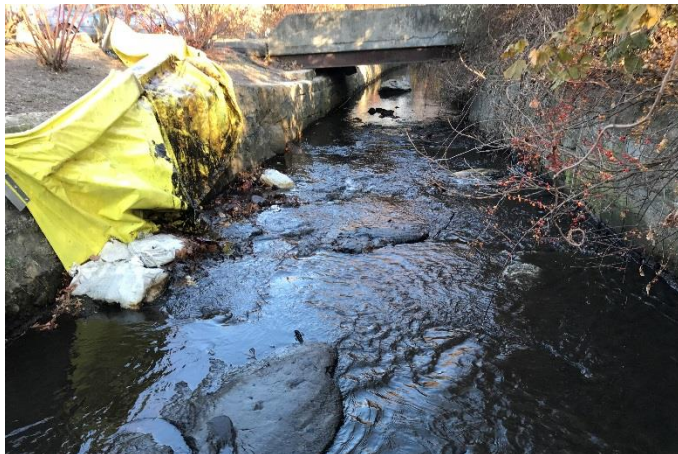
Friday (11/15/2019)

**Station 1 (Petrini Property) – Turbidity curtain removed, as approved by DEP.**

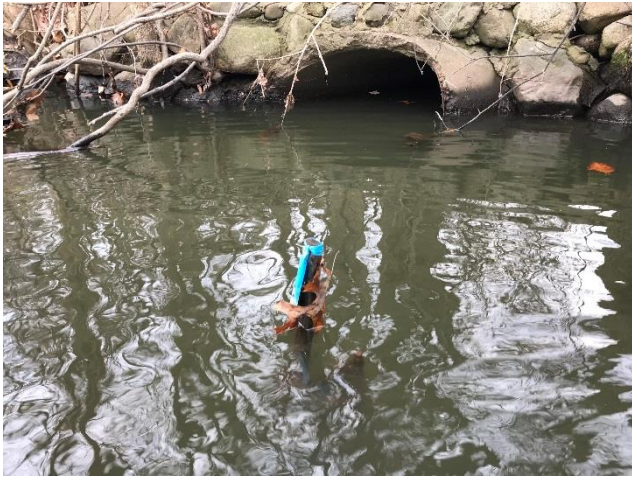
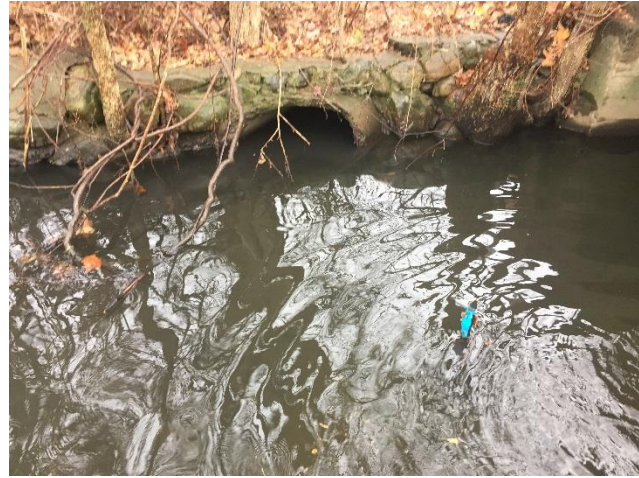
**Station 2 (West Street) – Turbidity, velocity, and sediment depth readings taken on Monday, Tuesday, and Friday.**

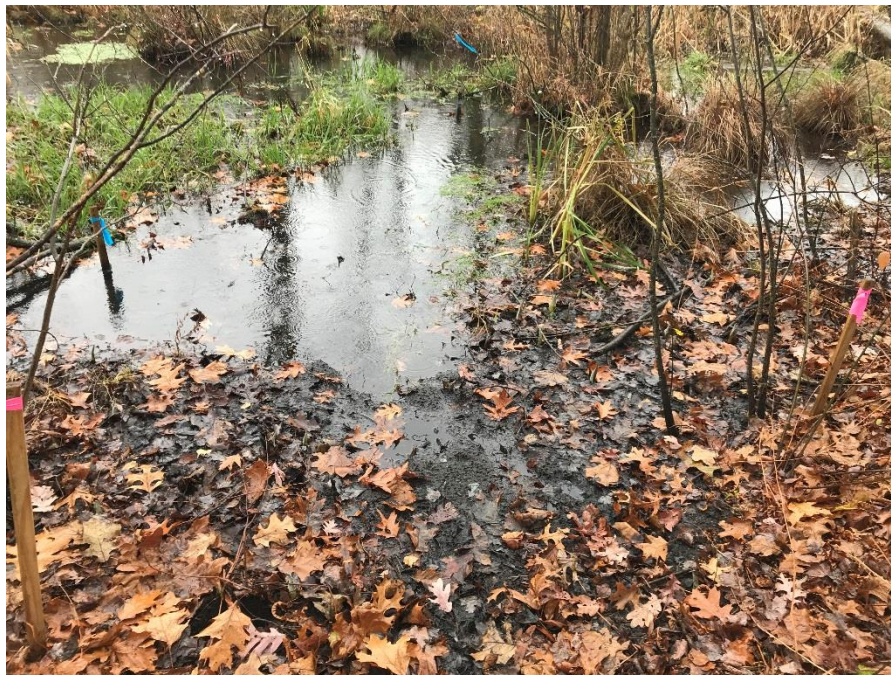
Station 5.1 and 5.2 (11/12/2019)

**Station 5.1 and 5.2 – Edge of Bank shown. Turbidity, velocity, and sediment depth readings taken on Tuesday and Friday. Rain occurred during monitoring.**

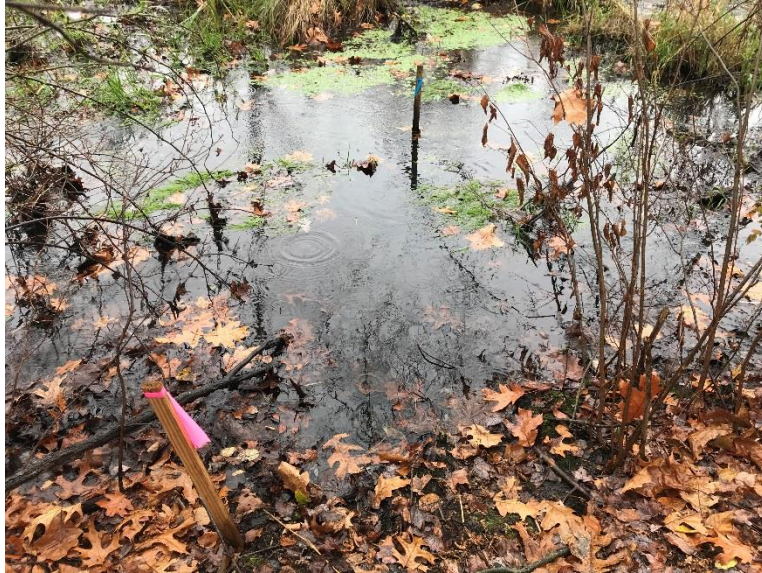
Station 5.3(11/12/2019)

**Station 5.3 – Edge of Bank shown. Turbidity, velocity, and sediment depth readings taken on Tuesday and Friday. Rain occurred during monitoring.**

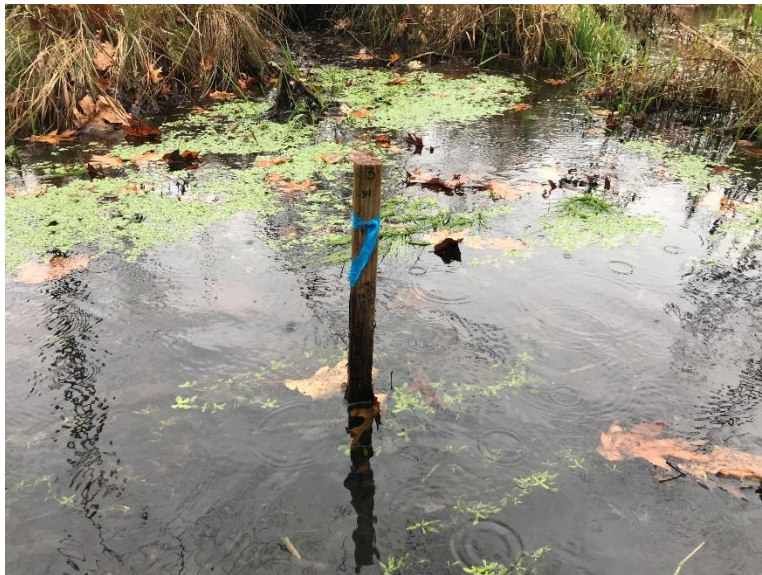
Station 5.3(11/12/2019)

**Station 5.3 – Turbidity, velocity, and sediment depth readings taken on Tuesday and Friday. Rain occurred during monitoring.**

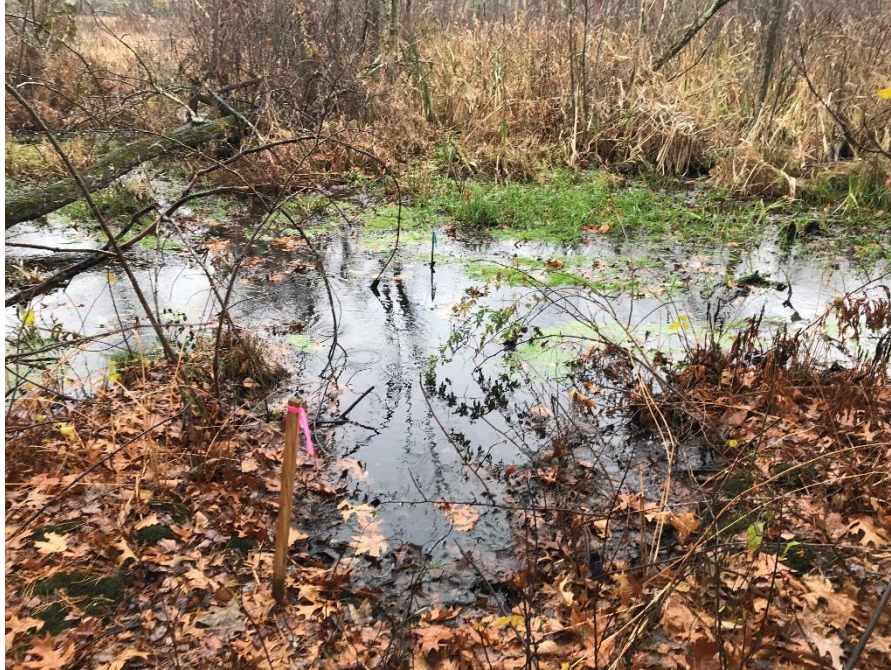
Station 5.4 (11/12/2019)

**Station 5.4– Edge of Bank shown. Turbidity, velocity, and sediment depth readings taken on Tuesday and Friday. Rain occurred during monitoring.**

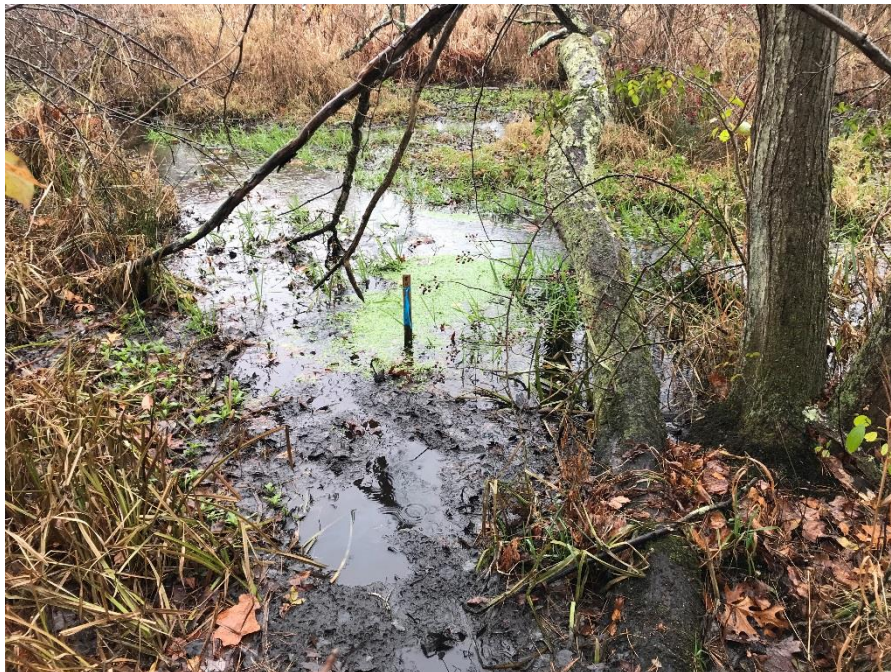
Station 5.5 (11/12/2019)

**Station 5.5 – Edge of Bank shown. Turbidity, velocity, and sediment depth readings taken on Tuesday and Friday. Water level lower than previous monitoring event (Thursday 11/7/2019).**

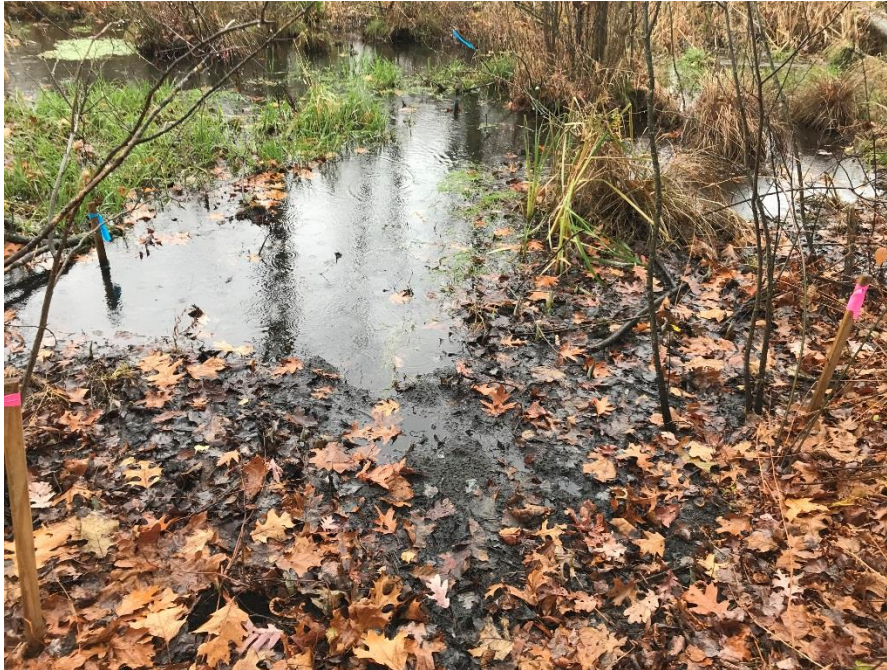
Station 5.1 and 5.2 (11/12/2019)

**Station 5.1 and 5.2 – Edge of Bank shown. Turbidity, velocity, and sediment depth readings taken on Tuesday and Friday. Rain occurred during monitoring.**
